WOODRIDGE LAKE DAM

WARREN COUNTY, MISSOURI

MO 11005

## PHASE I INSPECTION REPORT NATIONAL DAM SAFETY PROGRAM

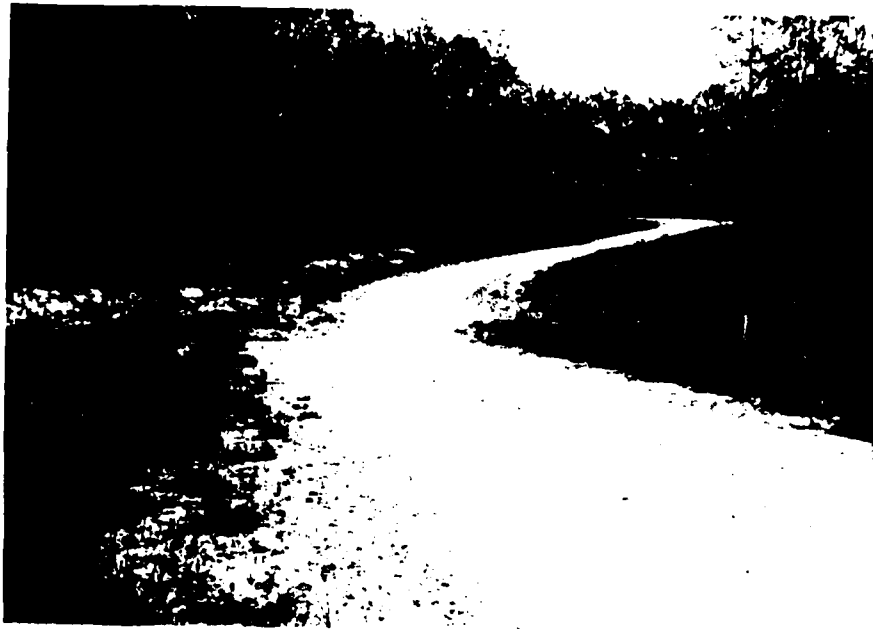
D11

The general condition of the emergency spillway is satisfactory. However, it appears that discharges through the spillway will flow down the left abutment contact. Some erosion gullies having a maximum size of 3 feet deep by 3 feet wide have formed along the abutment contact at this time. Discharges through the spillway flow into a slough area which has formed downstream of the toe of the dam. This area is marshy and filled with cattails and other phreatophyte.

The route of discharges through the emergency spillway threatens the structural integrity of the embankment. During a flood situation flows through the spillway could potentially erode a substantial amount of the embankment. This condition must be remedied by channelization of the route of the spillway discharges away from the embankment.

The left abutment contact is being further damaged by flows through the emergency spillway. This condition should be remedied by channelizing the discharges through the spillway away from the embankment. Following this work, the marshy condition and ponds at the downstream toe of the embankment should be drained and filled with compacted earth-fill.
